Asbestos Survey Report

Simpson Timber Company
Property Acquisition - 11 Building

**Simpson Timber Company Property Acquisition
11 Buildings**

**Distribution Control No.: 99126.990308.01
Contract/Purchase Order No.: SA 3655**

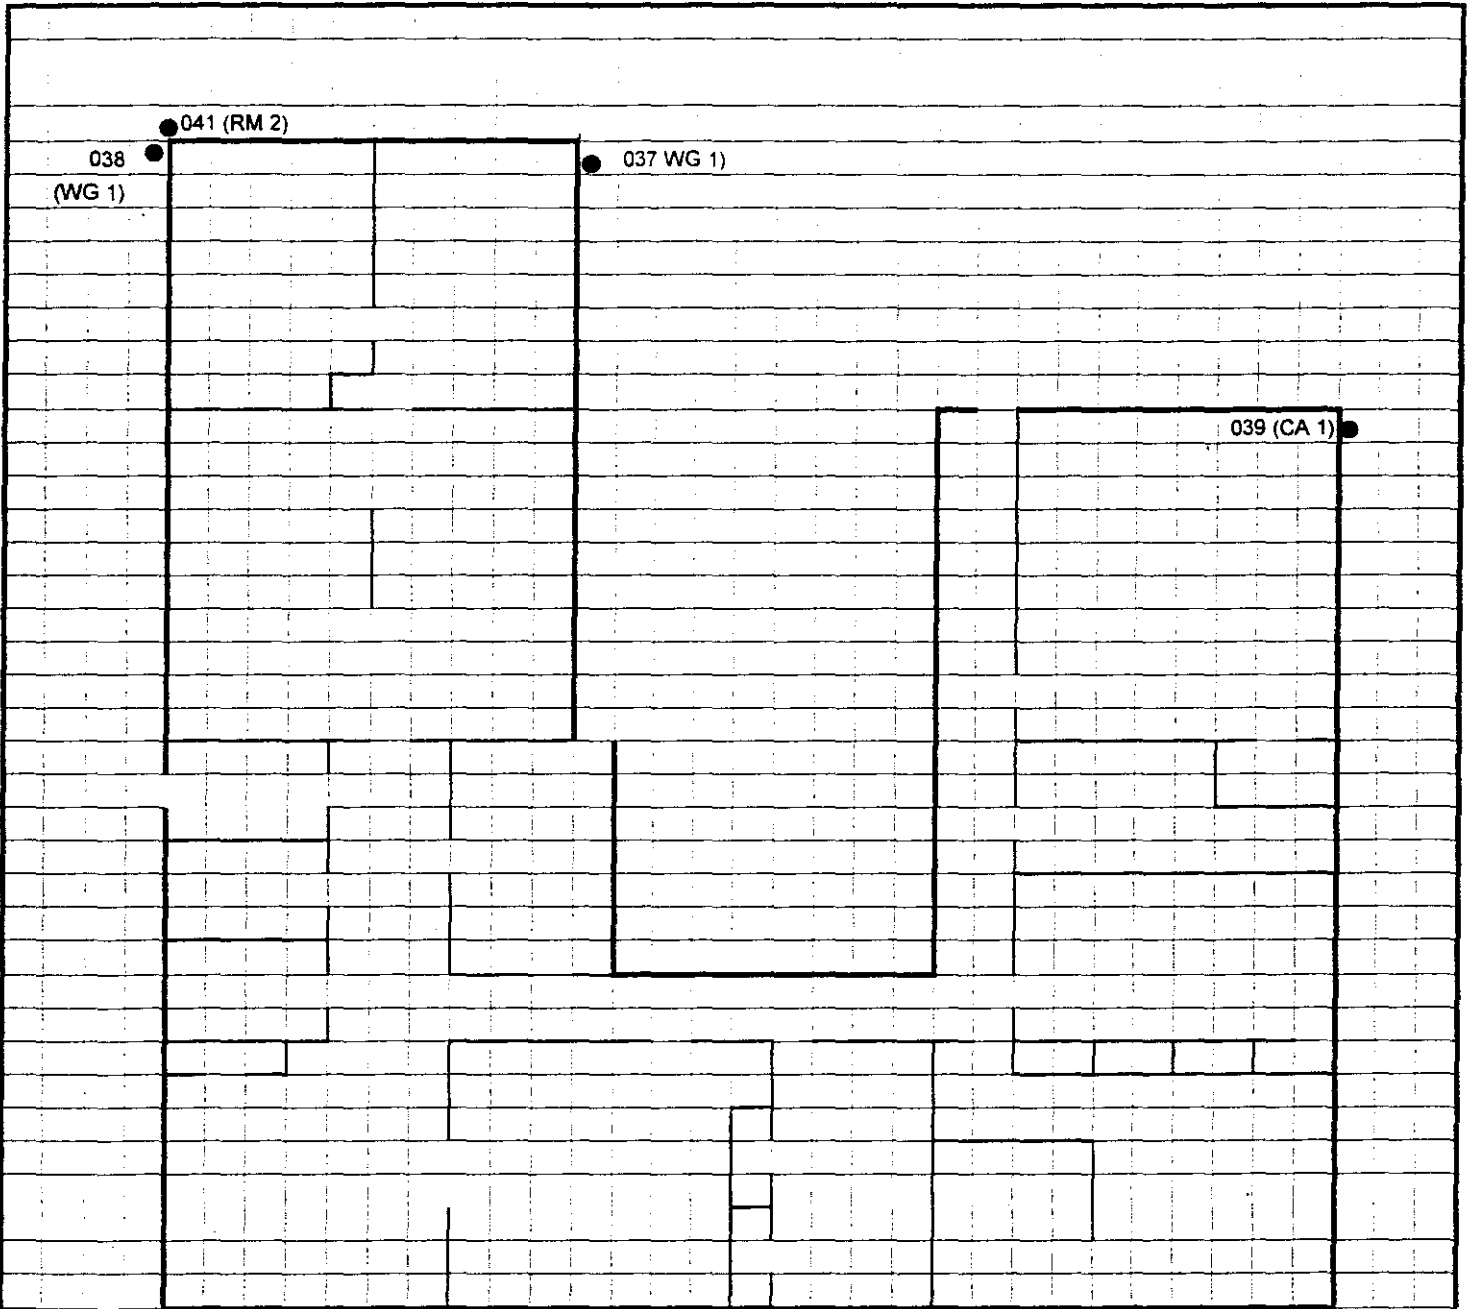
Building Number	Location or Area Utilization			Direction North
300 Middle Waterway	Office Building Exterior Sample Location			←
Drawn By	Project Number	Date	Time	
Craig Thomas	99196	March 5, 1999	0900 hrs

1. Sample 040 (RM 1) Collected on Flat Roof at North Wing
2. Sample 043 (RM 3) Collected on Concrete North of North Wing

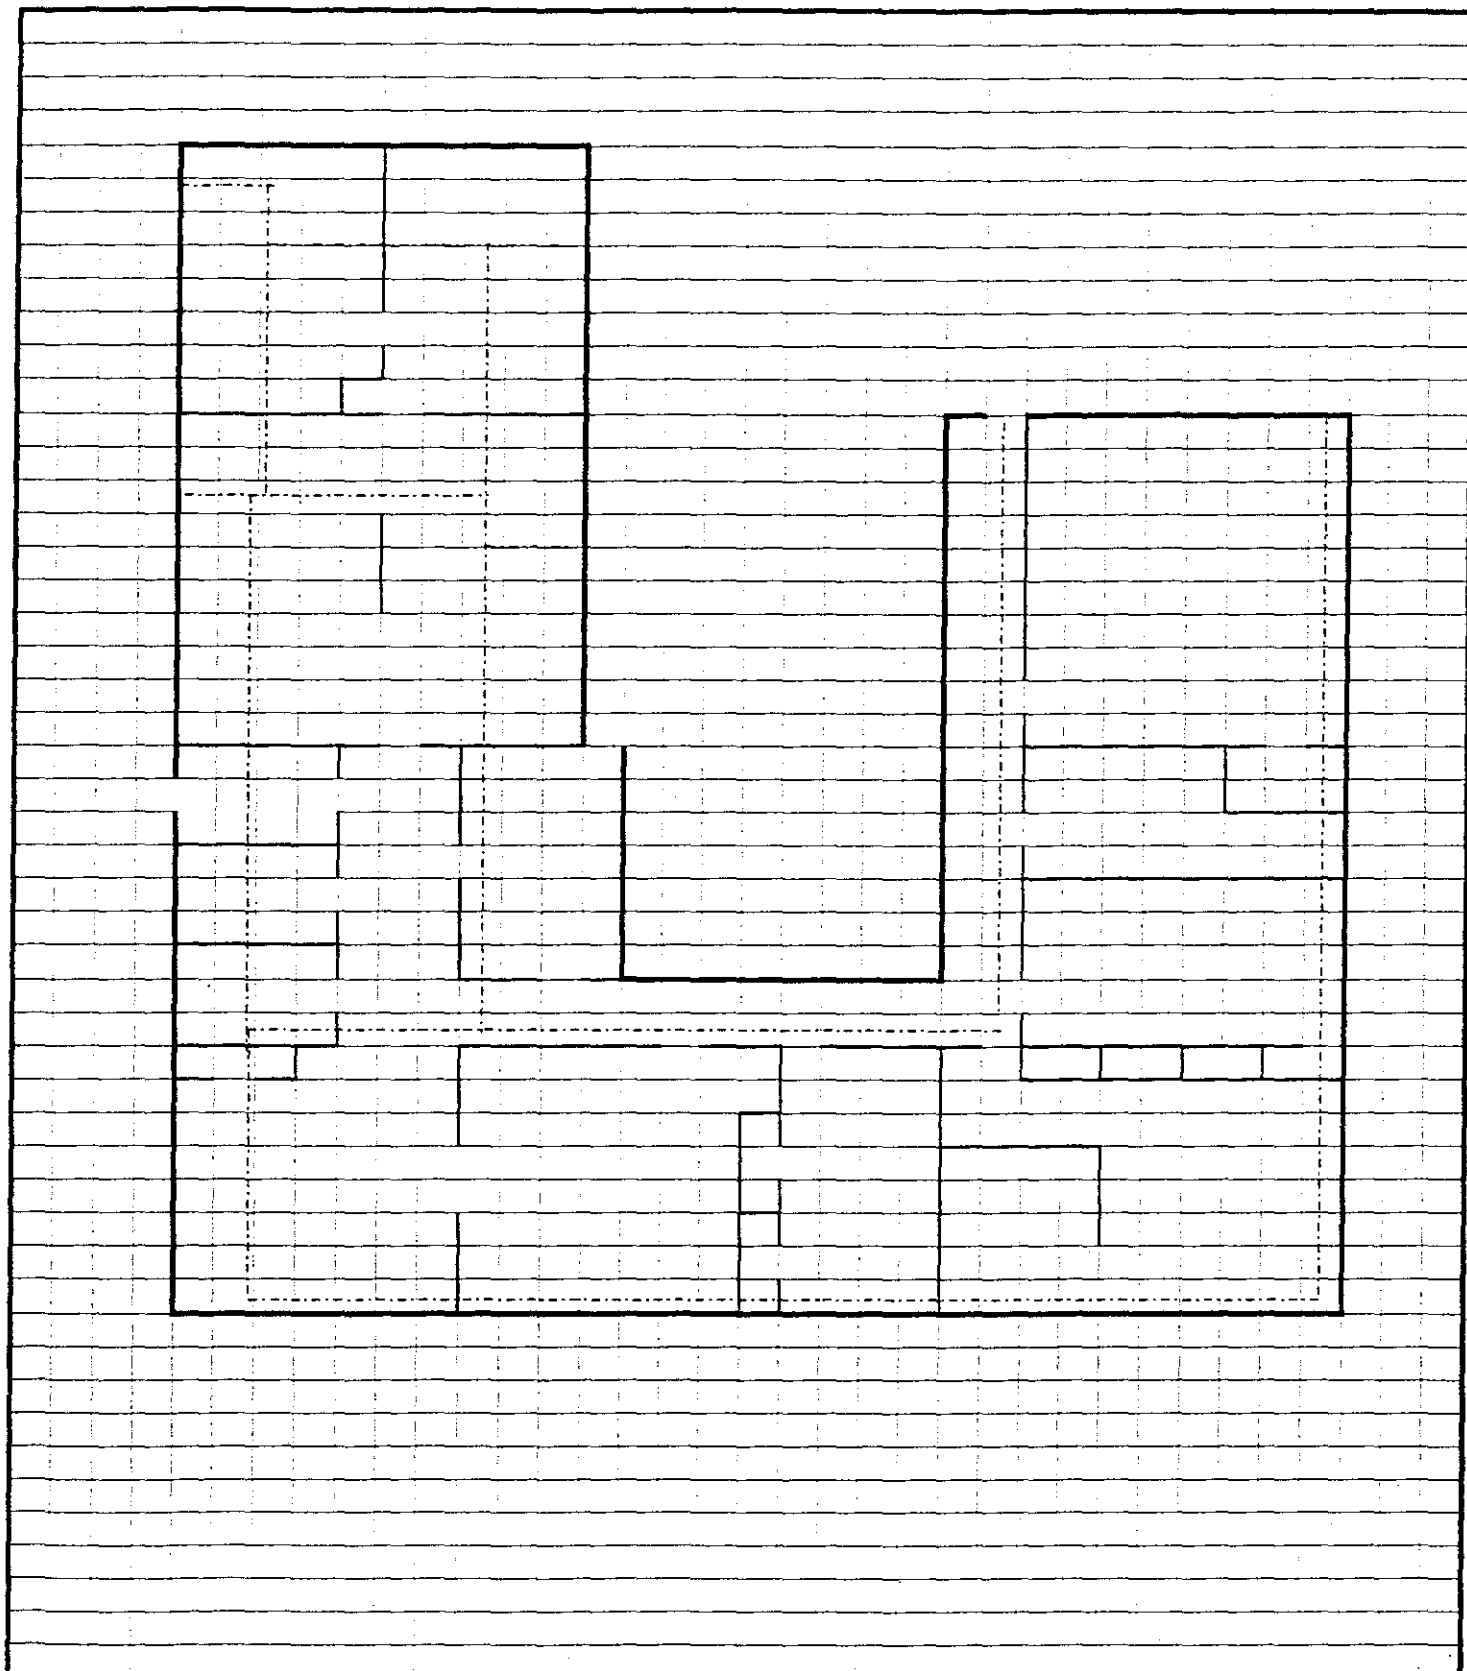
Building Number	Location or Area Utilization		Direction North
300 Middle Waterway	Office Building Crawl Space Pipe Location (Estimated)		←
Drawn By	Project Number	Date	
Craig Thomas	99196	March 5, 1999	Time 0900 hrs

This material was found through the crawl space area on domestic or steam water lines. This material was also found in the debris form on the soil. It was noted that this material may exist in penetrations into above flooring feeding into radiators that use to exist in the structure, as well as into the foundation.
